# Stability of beam trawlers

RC22C003-1999-rev04

After the two most recent capsizing incidents, with UK-165 'Lummetje' and UK-171 'Spes Salutis', the "Onderzoeksraad voor Veiligheid" (OVV - Dutch Safety Board) concluded that more extensive research needed to be done on the stability, stability rules and stability failures of beam trawlers.

*Establish the risks of capsizing and sinking induced by asymmetrical loads, for fishing vessels within the Dutch beam trawler fleet.*

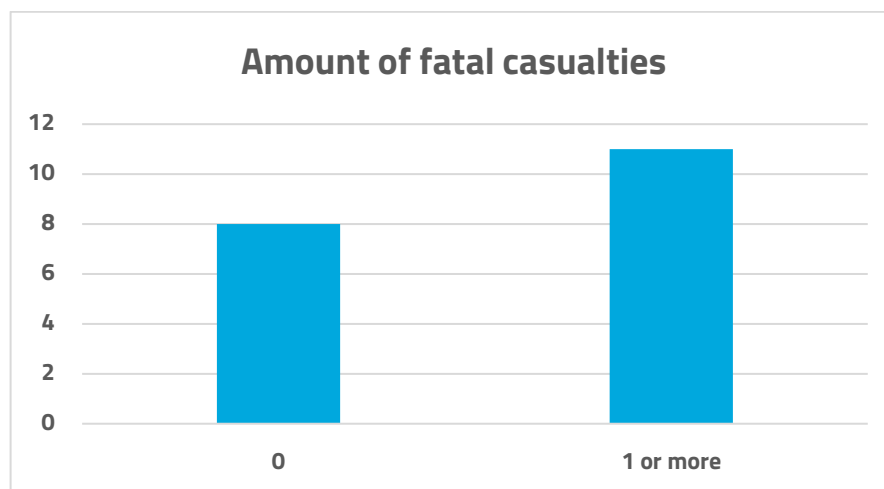
Number of fatal casualties: from the number of 19 investigated accident reports, covering a period of 1991 – 2020, the total number of fatal casualties is 34. Resulting in an average of 1.8 fatal casualties per accident. The diagram below shows that more than 50% of the accidents feature one or more fatal casualties.

Figure 1: Amount of fatal casualties involved in the analyzed accidents.

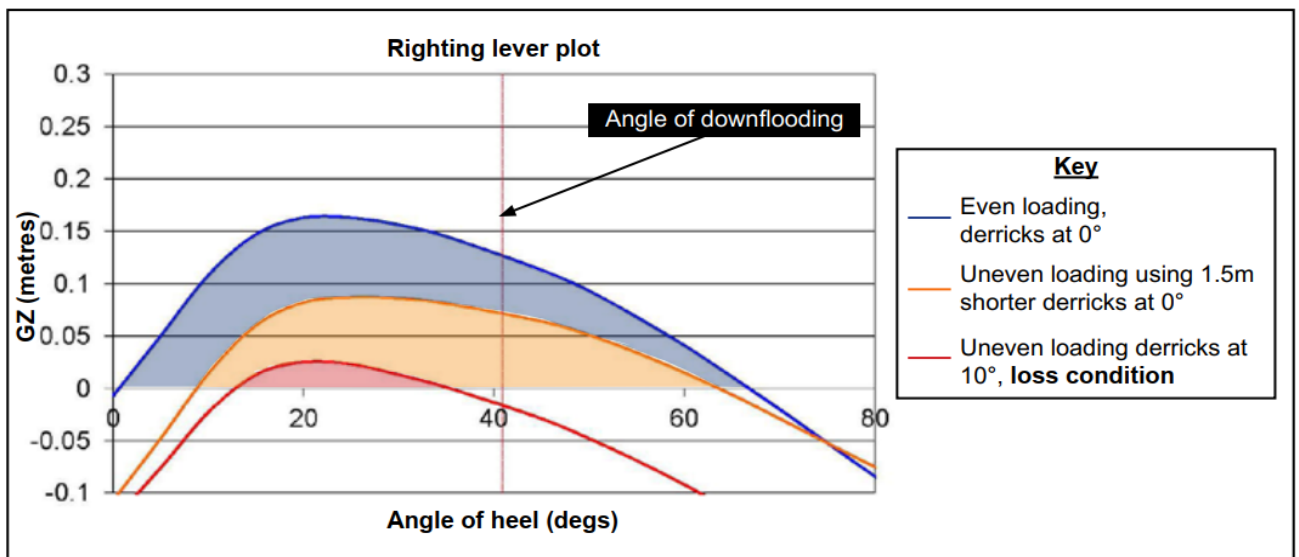
Figure 5 Righting lever plot showing the effect of several uneven loading conditions [ (MAIB, Capsize and foundering of beam trawler Sally Jane, 2014)]

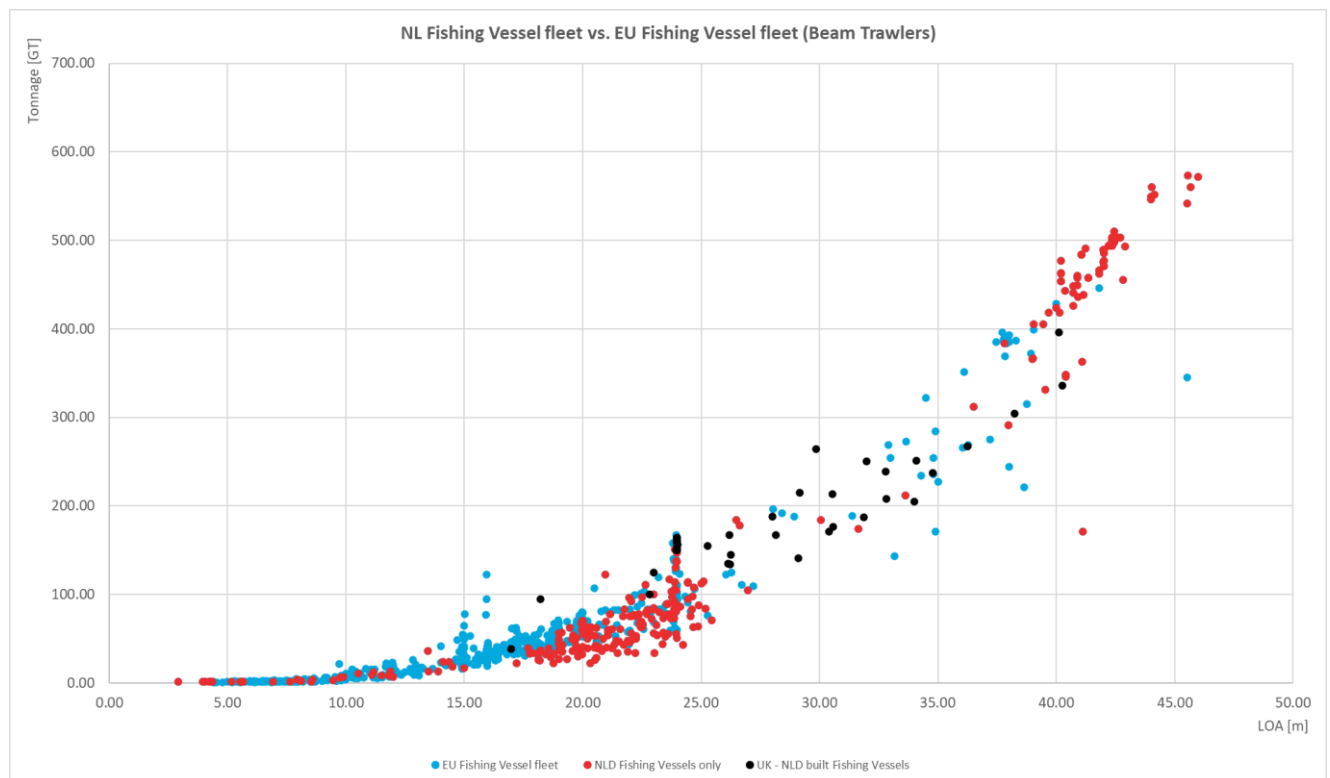
Figure 6: Dutch beam trawlers plotted in the total EU beam trawler fleet

As can be seen in Figure 6, the Dutch beam trawler fleet is concentrated in the length “categories” of 18 – 24 meters LOA and >40 meters LOA. Furthermore, Dutch built vessels that are registered in the UK are also plotted in this graph and it is noticed/stands out that the “gap” in the Dutch registered fleet between 24 and 40 meters LOA is partly filled by these UK registered Dutch built vessels.

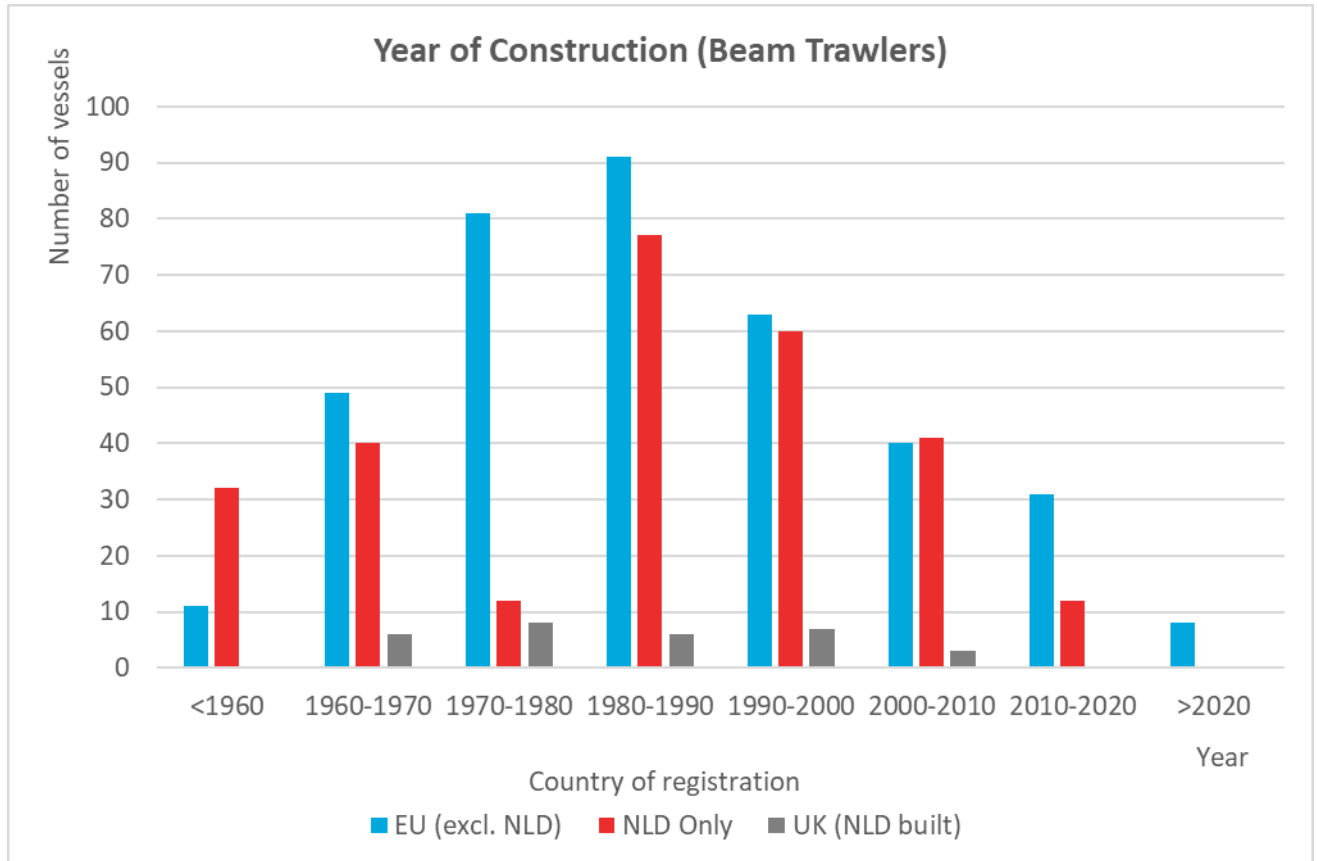
Conoship has a rich history of fishing vessels and beam trawlers designed and built, mainly from the late 1980's and early 1990's. It shows that in this period, only large beam trawlers were designed within the 2000 hp (1470 kW) limit.

Figure 7: Year of construction of Beam trawlers registered in the EU, NLD and UK

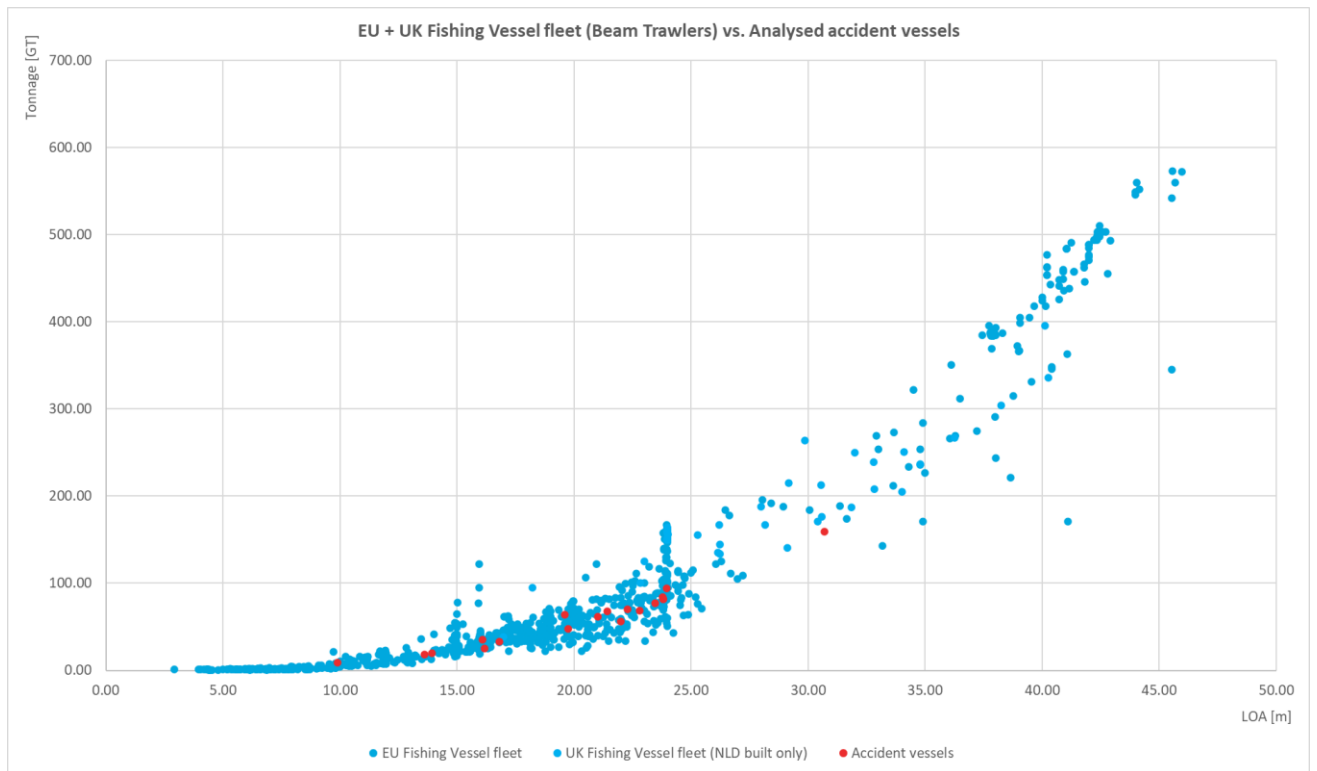
Figure 8: EU + UK Beam trawler fleet with the analyzed accident vessels plotted.

To provide more context this data is plotted in a graph resembling the EU + UK beam trawler fleet. See chapter 5, in Figure 8. This indicates how the wrecked vessels compare to the entire EU + UK fleet.

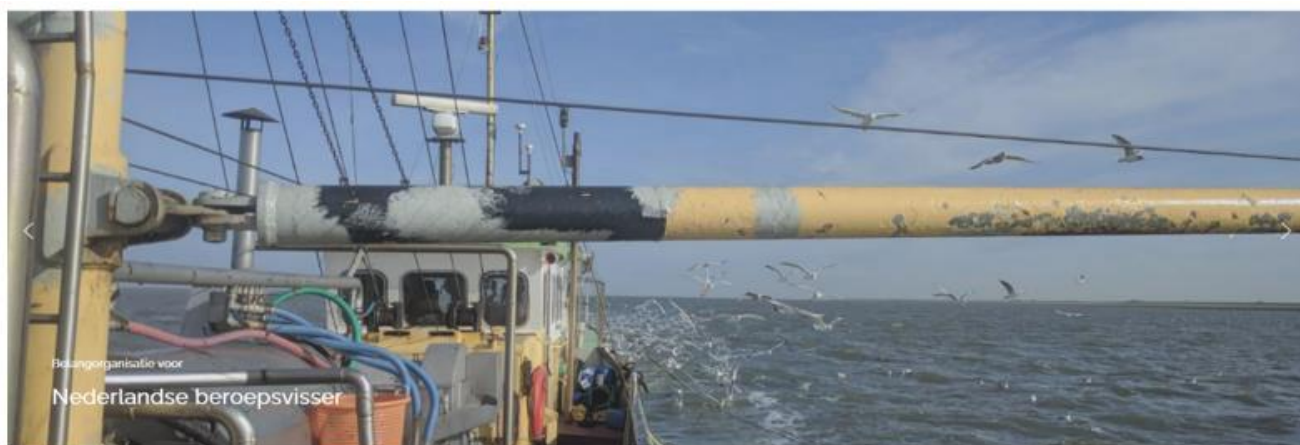
During interviews with inspectors of ILT and designers it became clear that derricks are regularly lengthened without updating the stability booklet. An example was found on the internet, showing a beam trawler with a clearly recently lengthened derrick.

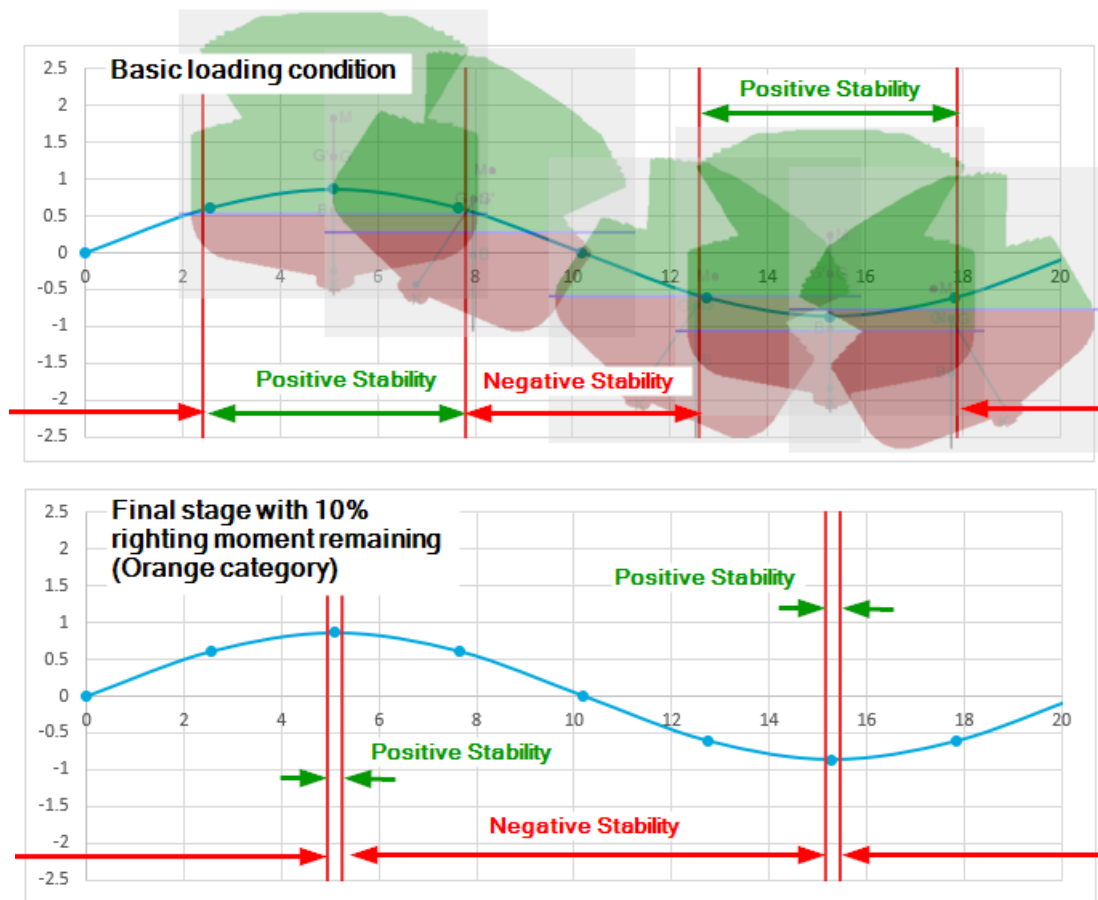
This shows that with a decrease in stability due to operational condition and/or external moments, vessels can be very vulnerable to capsize in transverse waves. The effect of the fishing gear in the water could not be included in this calculation but is considerable. Therefore, it has been chosen to include transverse waves in the qualitative analysis; in the FMEA-analysis (see chapter 7).

Figure 20: Example calculation of vessel stability in transverse waves (statical). A decrease in stability can make a vessel very vulnerable to capsize in transverse waves

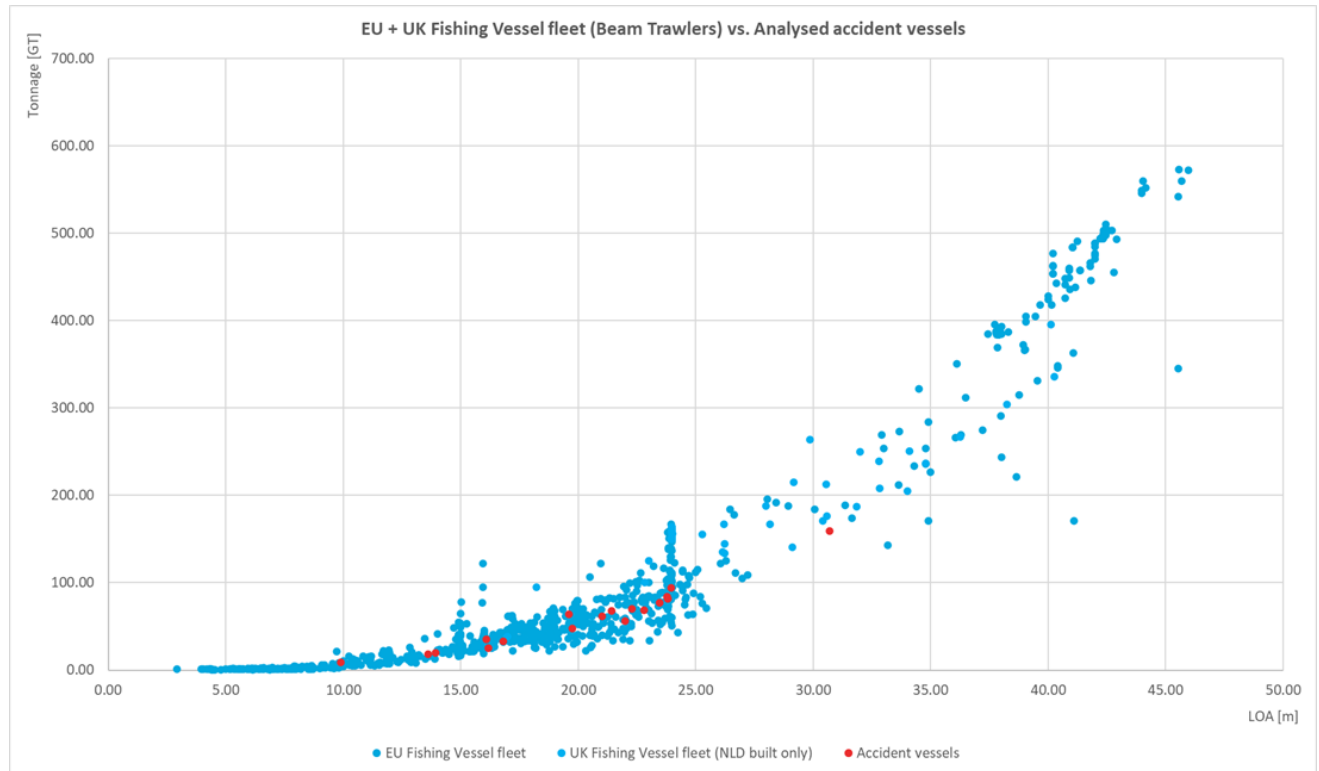
Except for one vessel, all investigated capsizing accidents happened to beam trawlers of 24 m or less, as can be seen in Figure 26. See also chapter 3.

Figure 26: Accident vessels compared to the entire beam trawler fleet

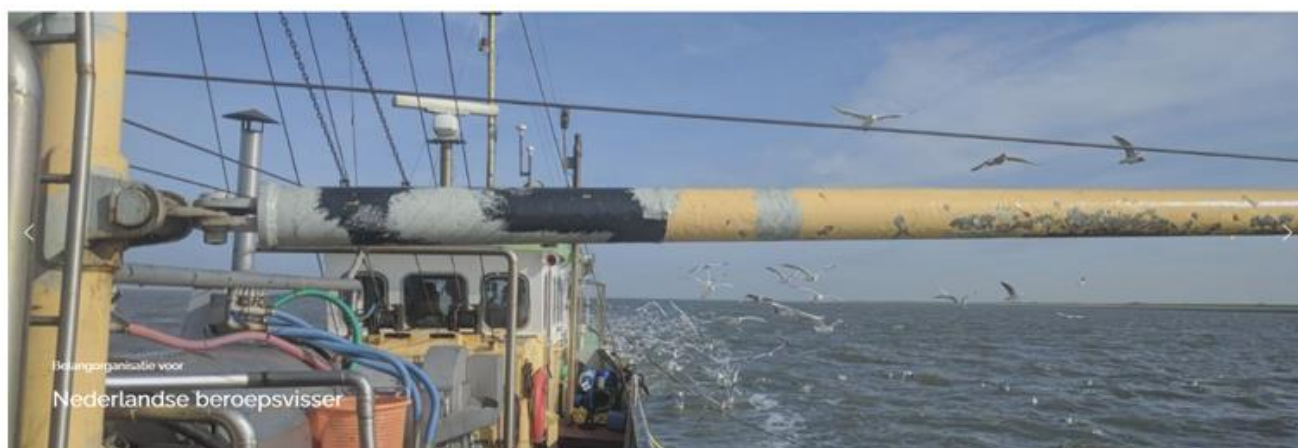
When a fishing gear is changed, the derricks are sometimes lengthened. An example is given in the picture below. Not always the stability information is updated for the derricks. Also, the effect of the longer derricks on the fishing conditions is not considered at all. Fishing conditions are not part of the stability information available to the master in the stability booklet.

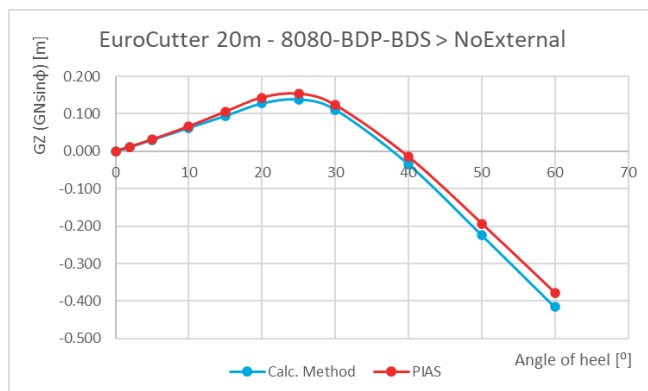
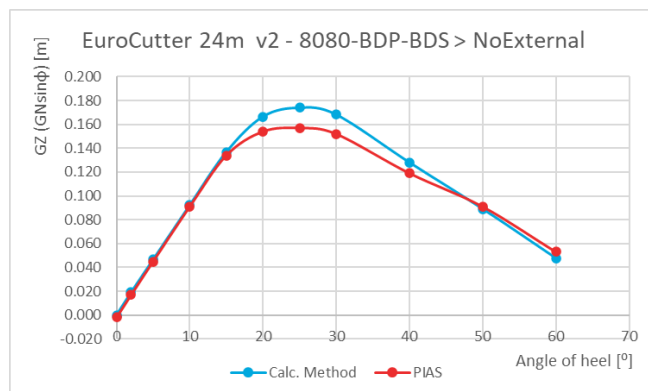
**EuroCutter 20m**

Operational condition	EuroCutter 20m		EuroCutter 24m v2 (Closed Aft deck)	
	8080-BDP-BDS		8080-BDP-BDS	
	NoExternal		NoExternal	
External moments	Calc. Method	PIAS	Calc. Method	PIAS
Resulting Displacement	111.3	111.3	257.9	257.9
Resulting VCG'	2.820	2.820	3.034	3.033
Resulting TCG	0.000	0.000	0.000	0.000
Resulting GM'	0.348	0.348	0.534	0.534
External moment	No	No	No	No
Resulting Max. GZ	0.138	0.153	0.174	0.157
Resulting angle of heel	0.0	0.0	0.0	0.0
Remaining Righting Moment	15.4	17.4	44.9	40.5
